Hydrogeological Impact Assessment for the Expansion of the Cruickshank Elginburg Quarry

Lot 12 and 13, Concession 5, City of Kingston, County
of Frontenac, Ontario

Report No. 2130039.00

February 22, 2016

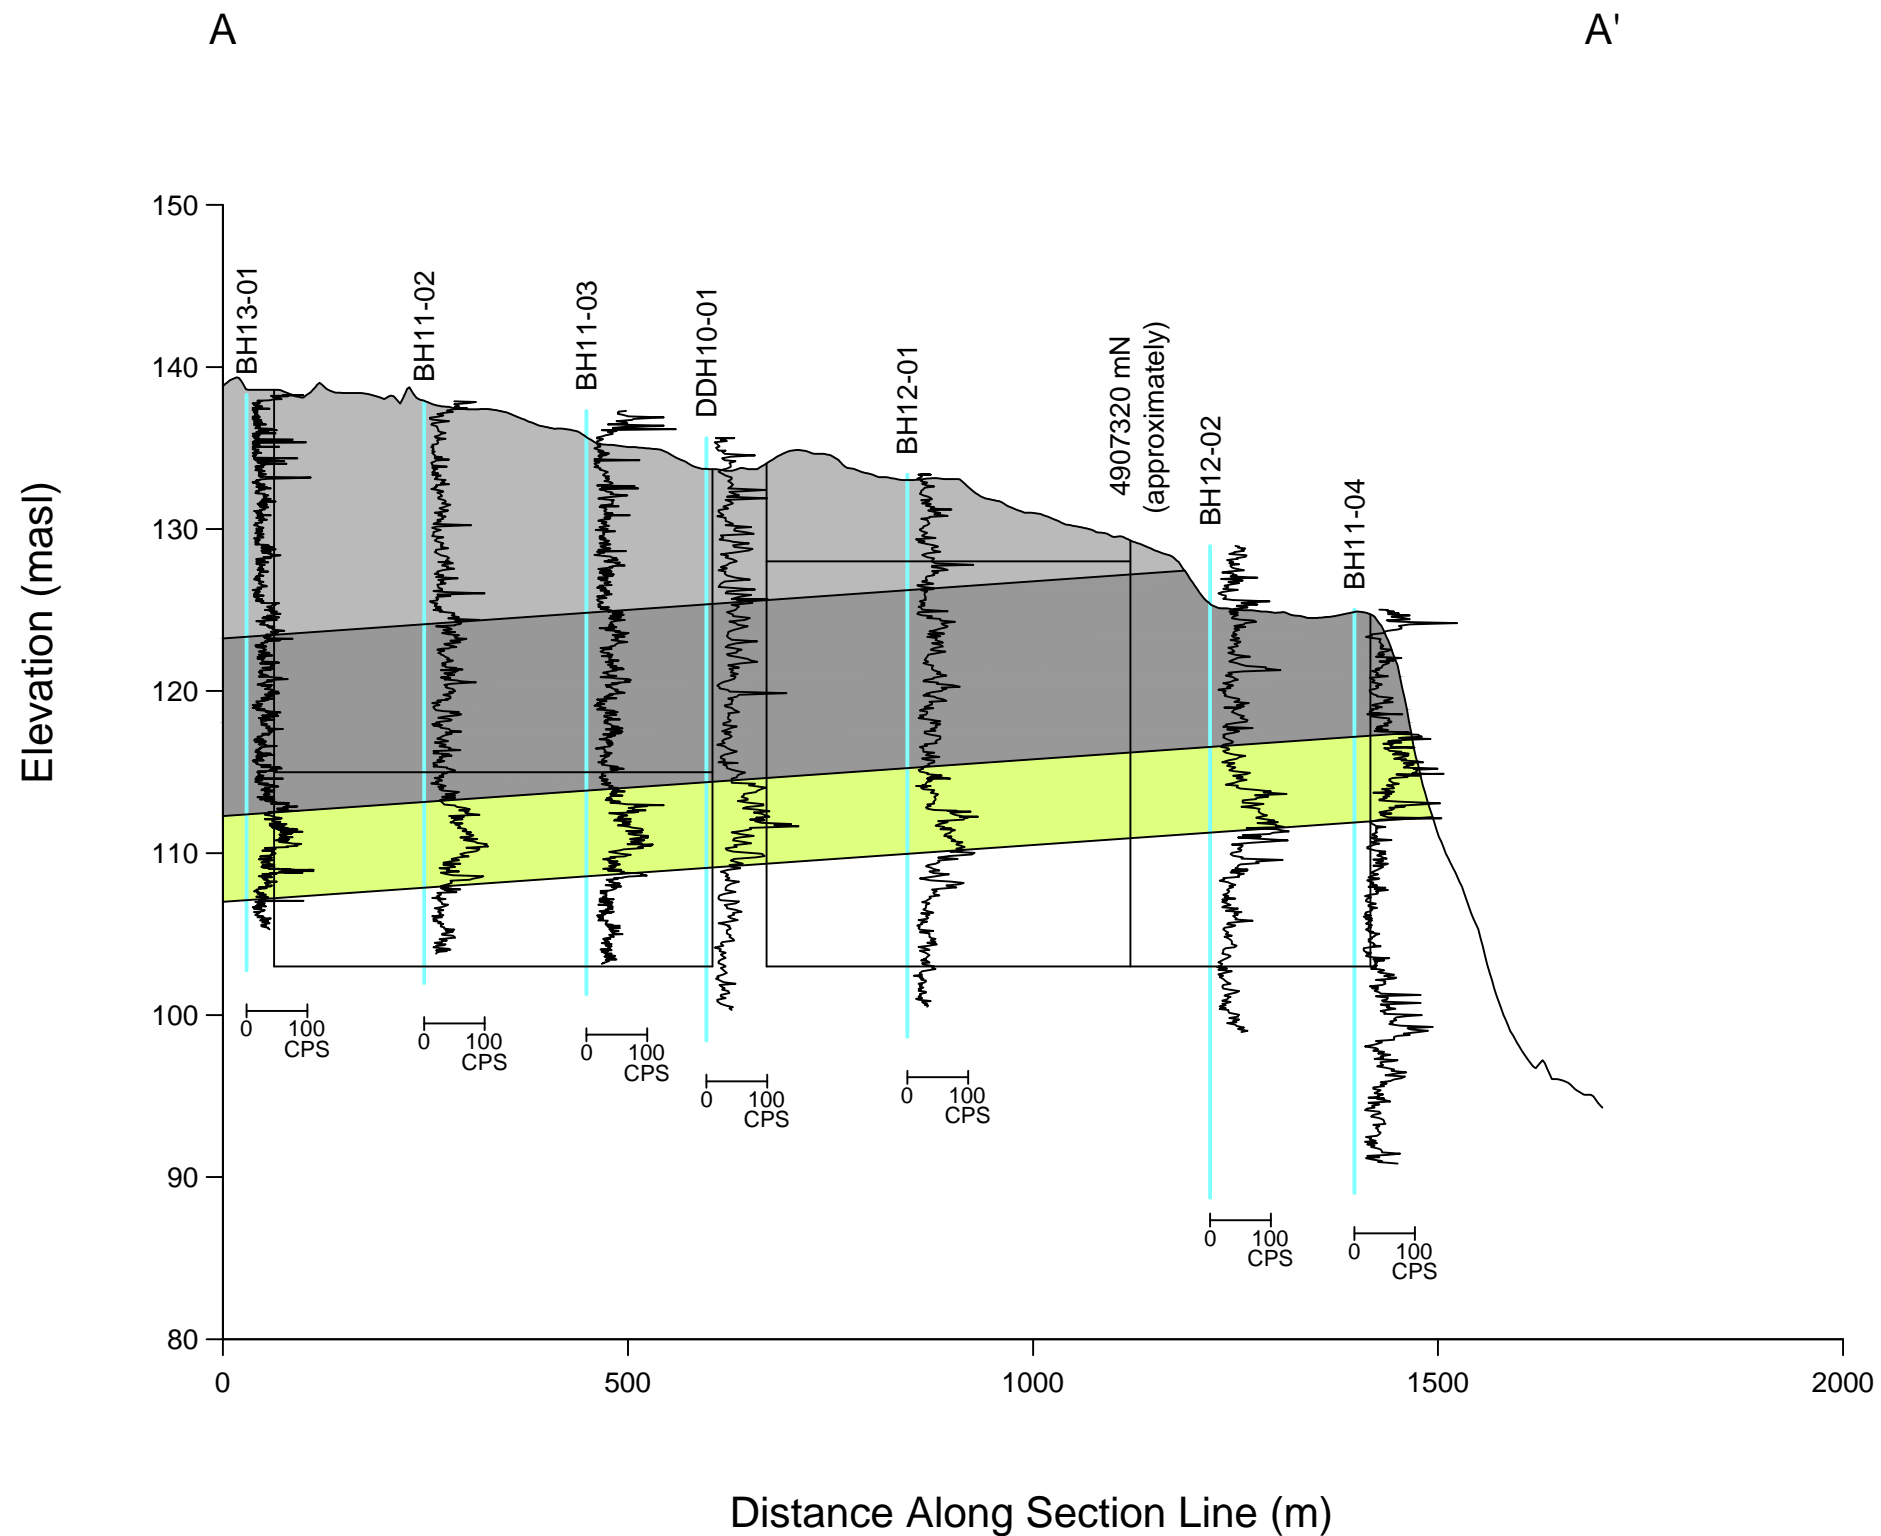
| Project No.: 2130039 | Drawing No.: Figure 3 |

- Light Grey Limestone
- Limestone with Dark Grey Beds
- Limestone with Green Beds
- Limestone

Title:
Stratigraphic Model based on Geophysical Logging

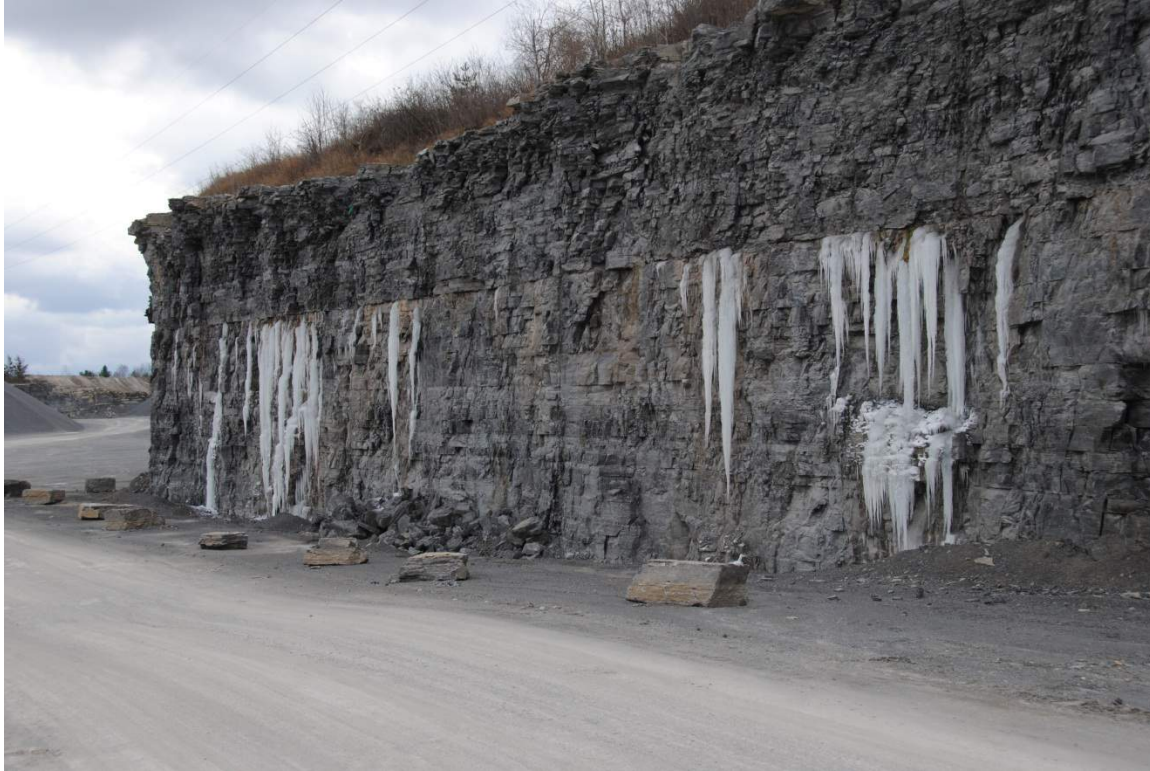
Photo 1: Ice on west wall of south existing quarry, approx. elevation 128 masl, taken Nov. 25, 2013

Site inspections were carried out on November 25, 2013, January 10, 2013, and May 29, 2014 (for surface water). The temperature was below freezing on both 2013 days, and frozen discharged groundwater could be observed at various point locations on the quarry walls. An apparently water-bearing fracture was observed at approximately 128 mASL in both the north and south extraction areas. Photographs from the site inspection are included in Appendix D.

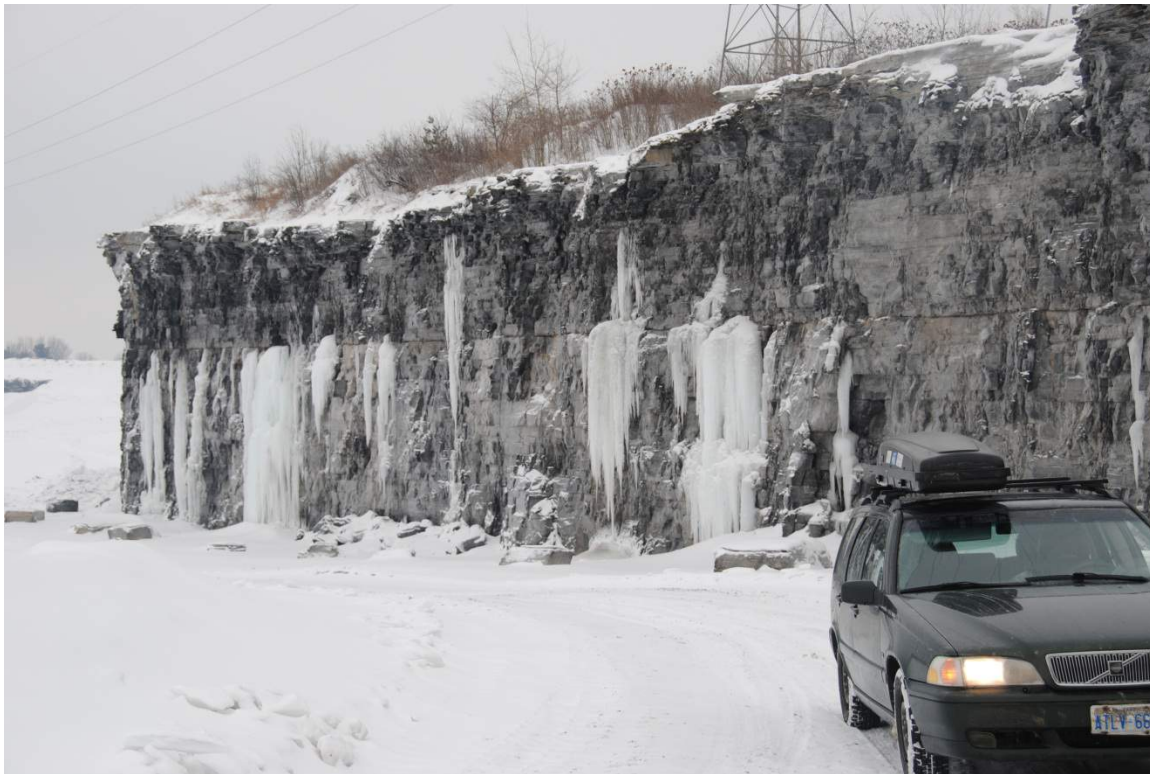
Photo 2: Same location, on January 10, 2014

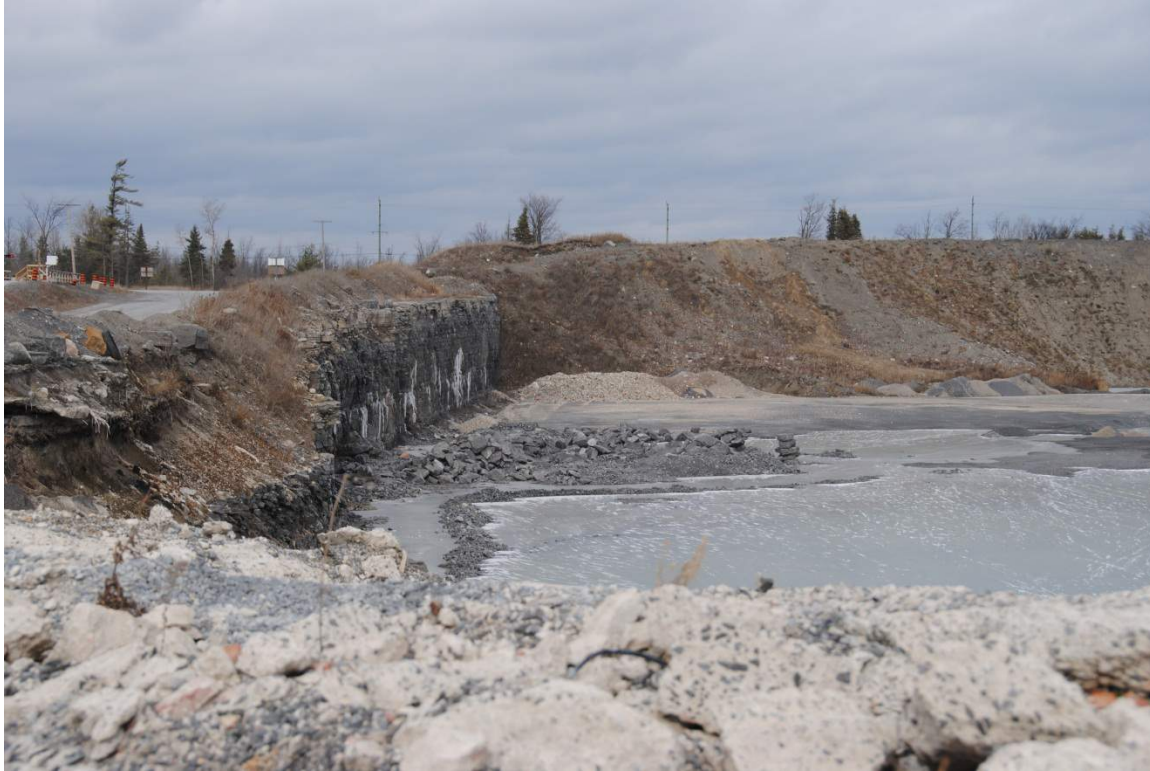
Photo 3: North quarry, looking north.
Note the same ice production at approximately 128 masl.

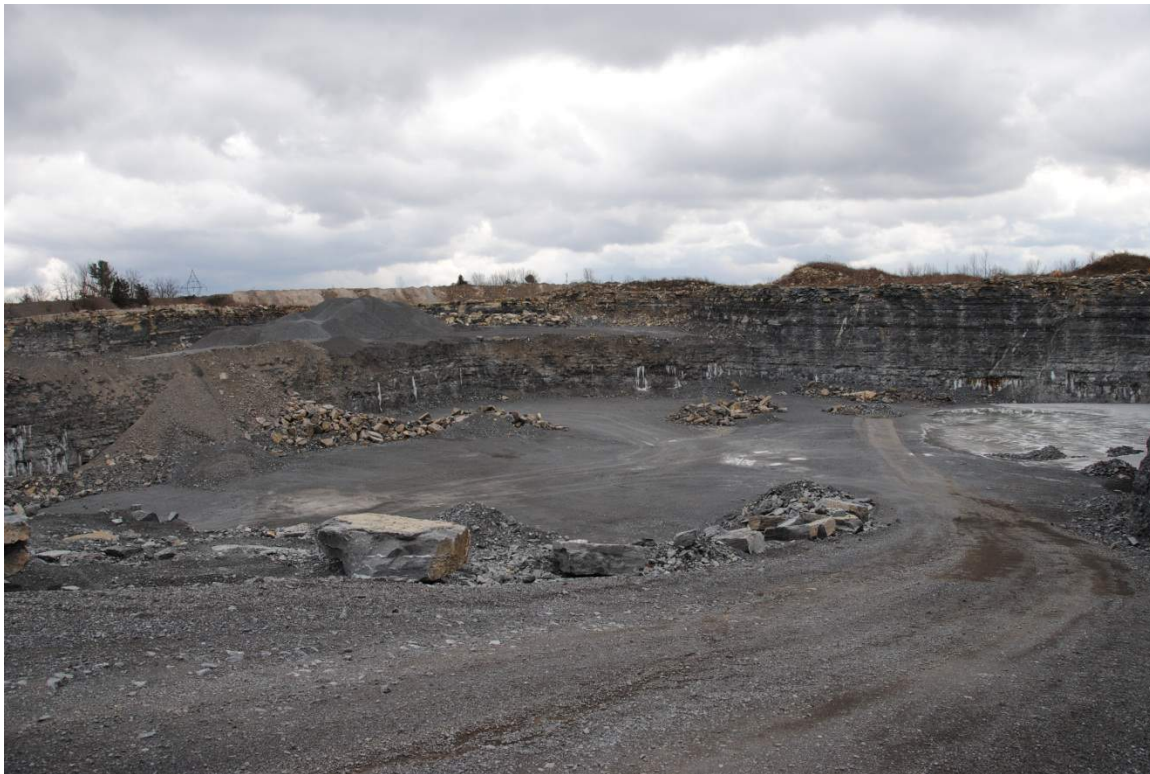
Photo 4: South quarry, looking south.
Note the ice at various locations, at approximately 120 masl.

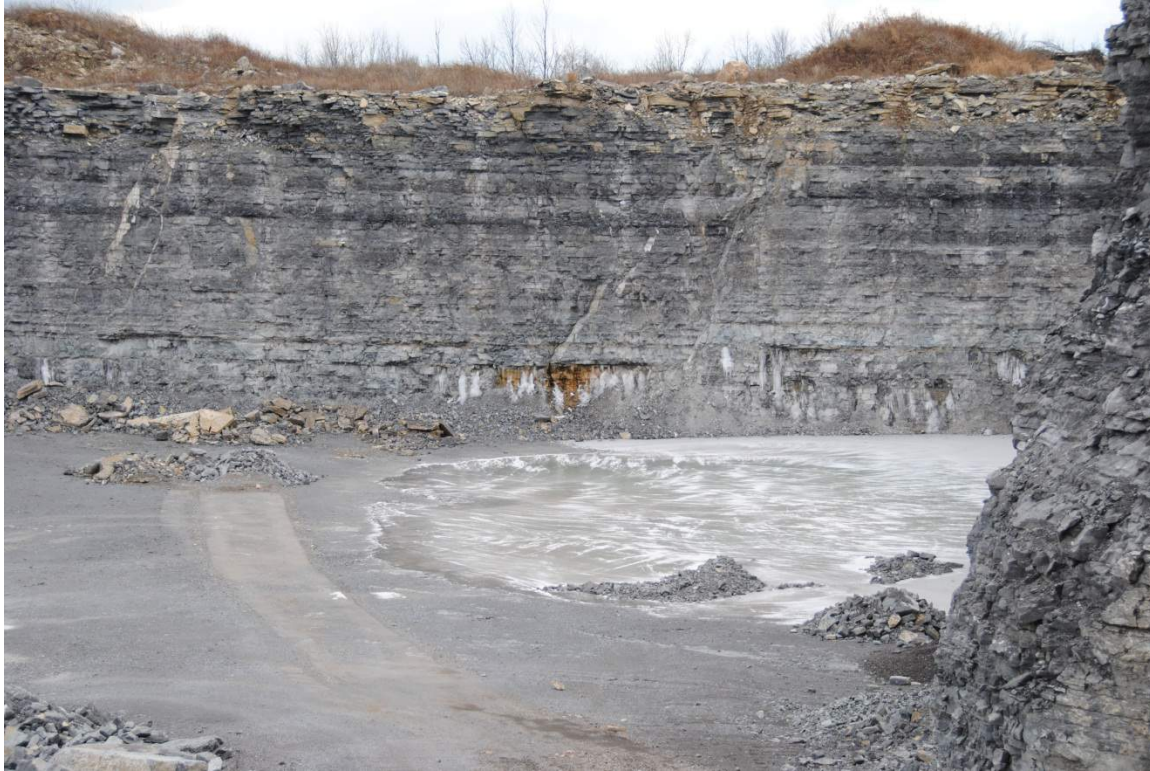
Photo 5: South wall of south quarry. Note the ice at approximately 120 masl.

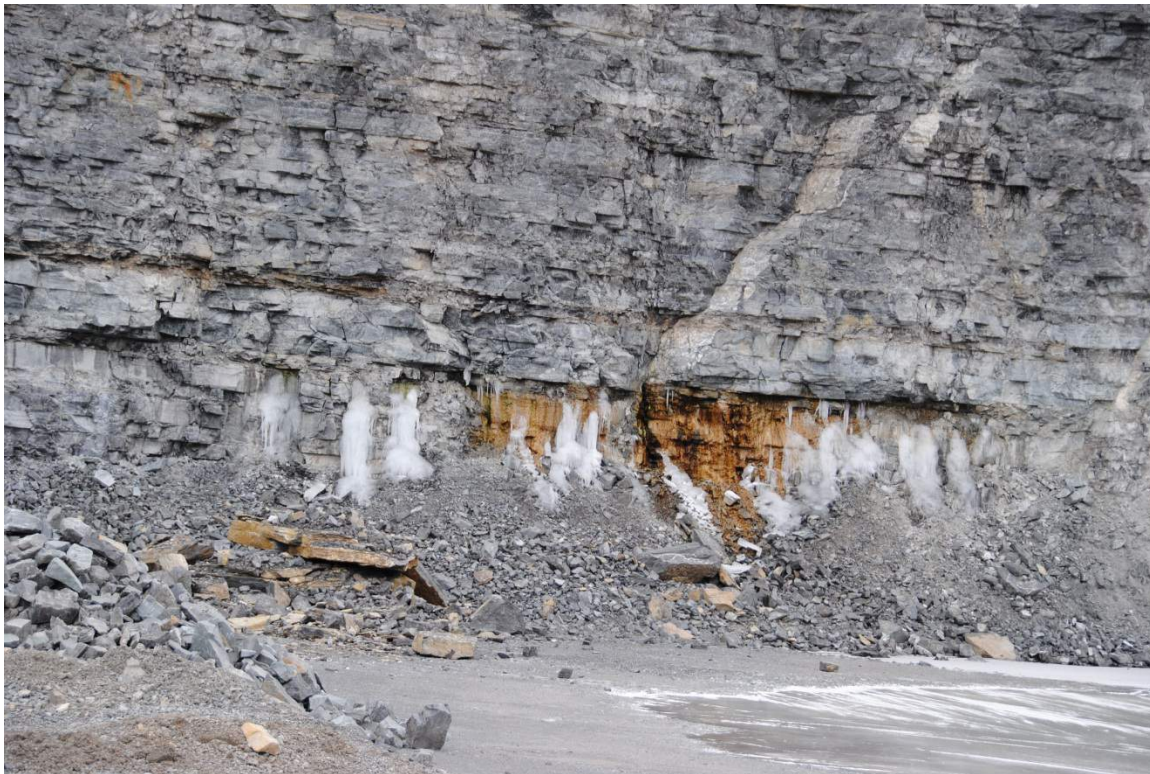
Photo 6: Close up of rust staining and ice at point groundwater discharge location.

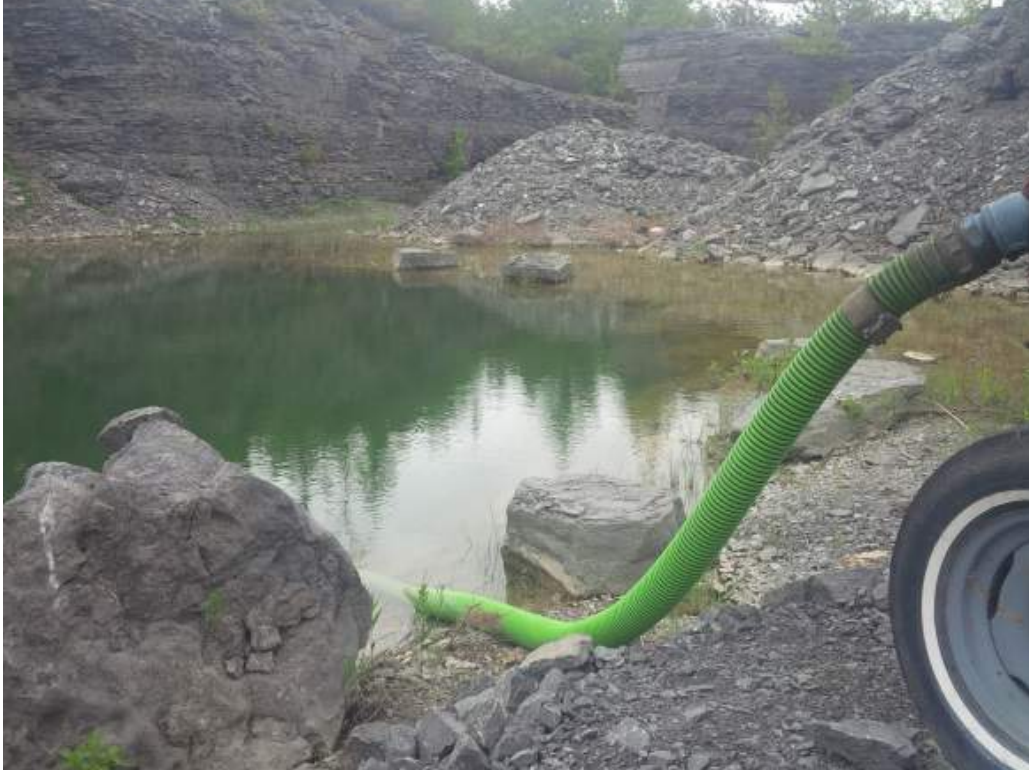
Photo 7: Pumping from the sump of north excavation

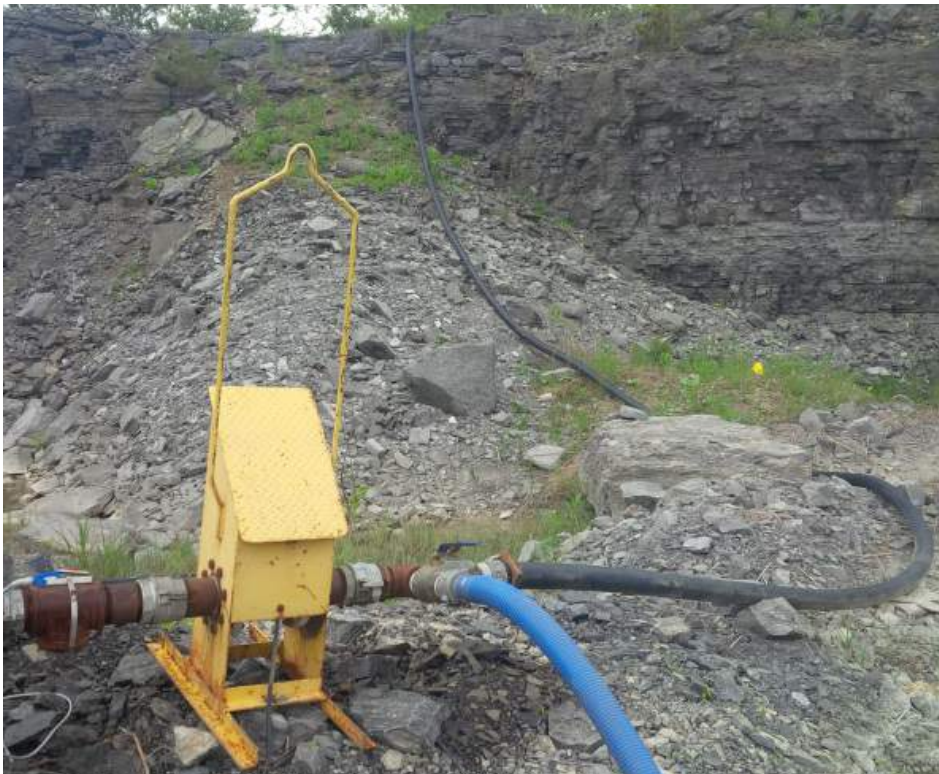
Photo 8: North pump junction. Black pipe goes to culvert and to south quarry (SW1)

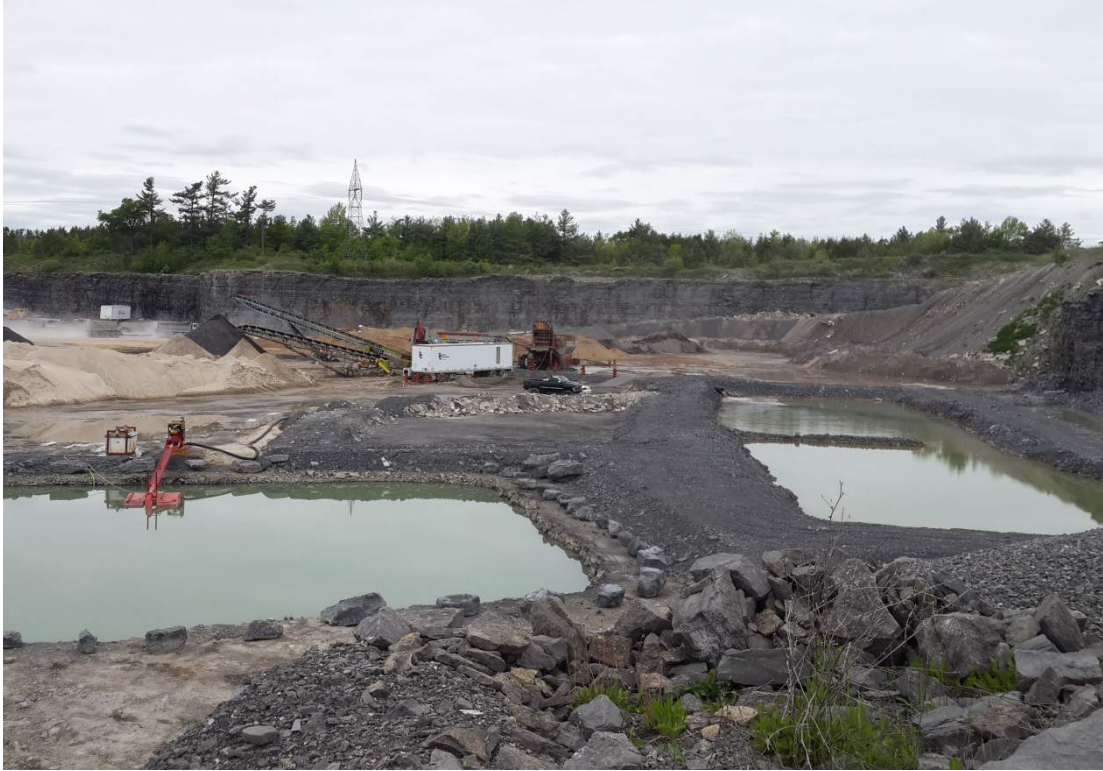
Photo 9: Wash plant sediment ponds in south quarry

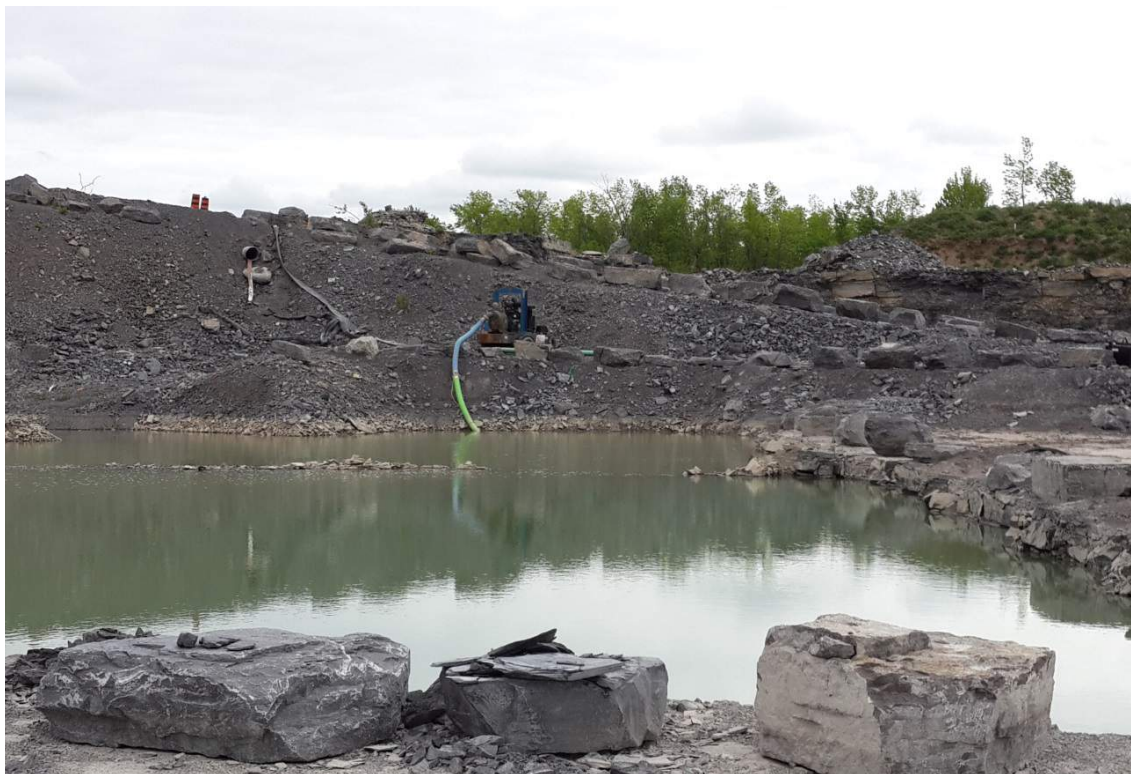
Photo 10: Wash plant pond with pump for flood events

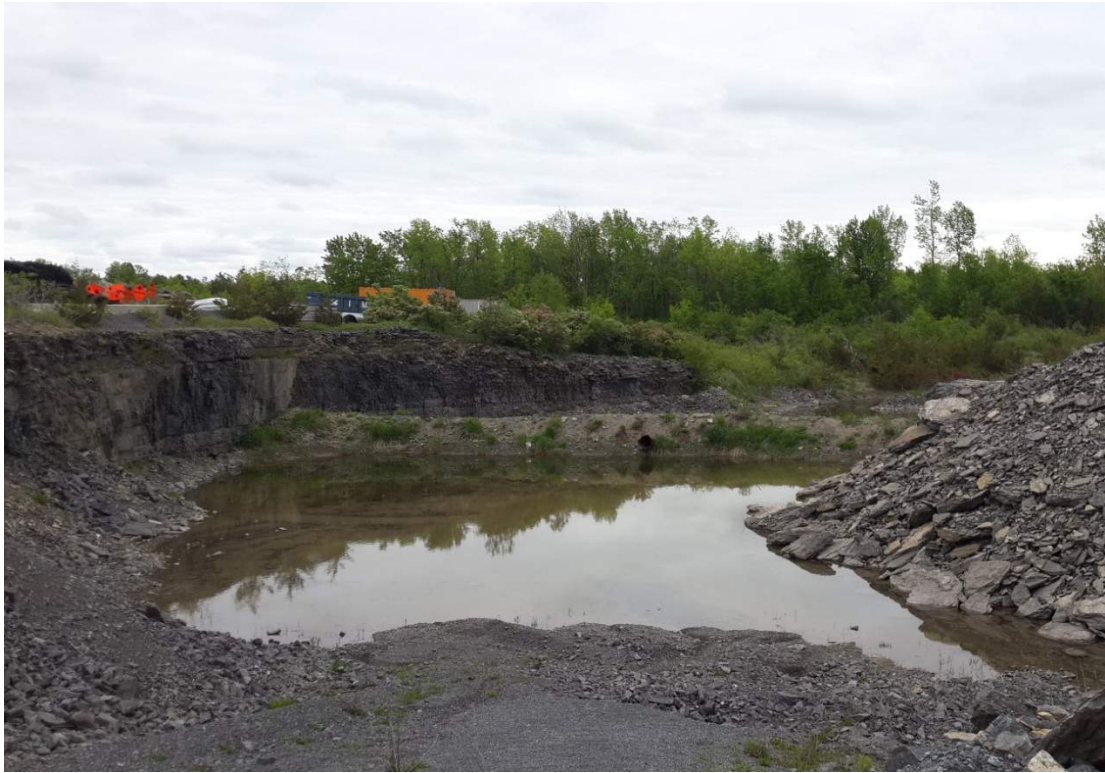
Photo 11: Overflow sediment pond (SW2)

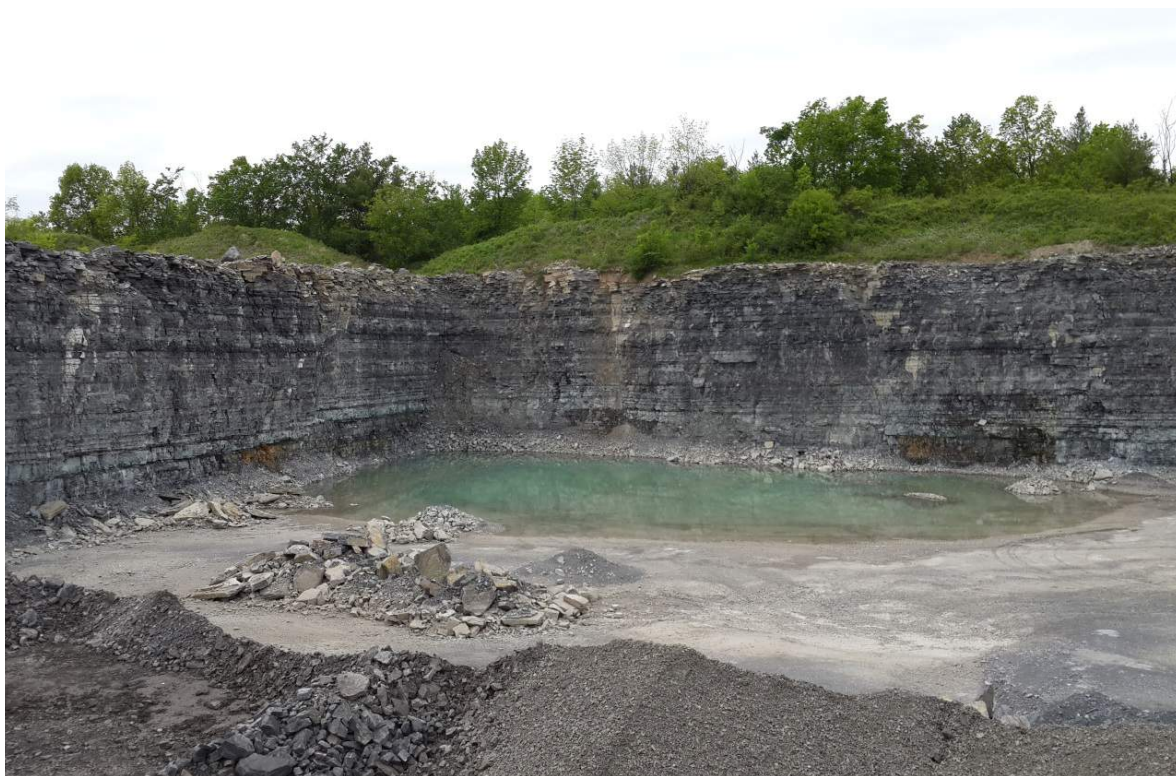
Photo 12: Southwest corner of south quarry, with ponded water

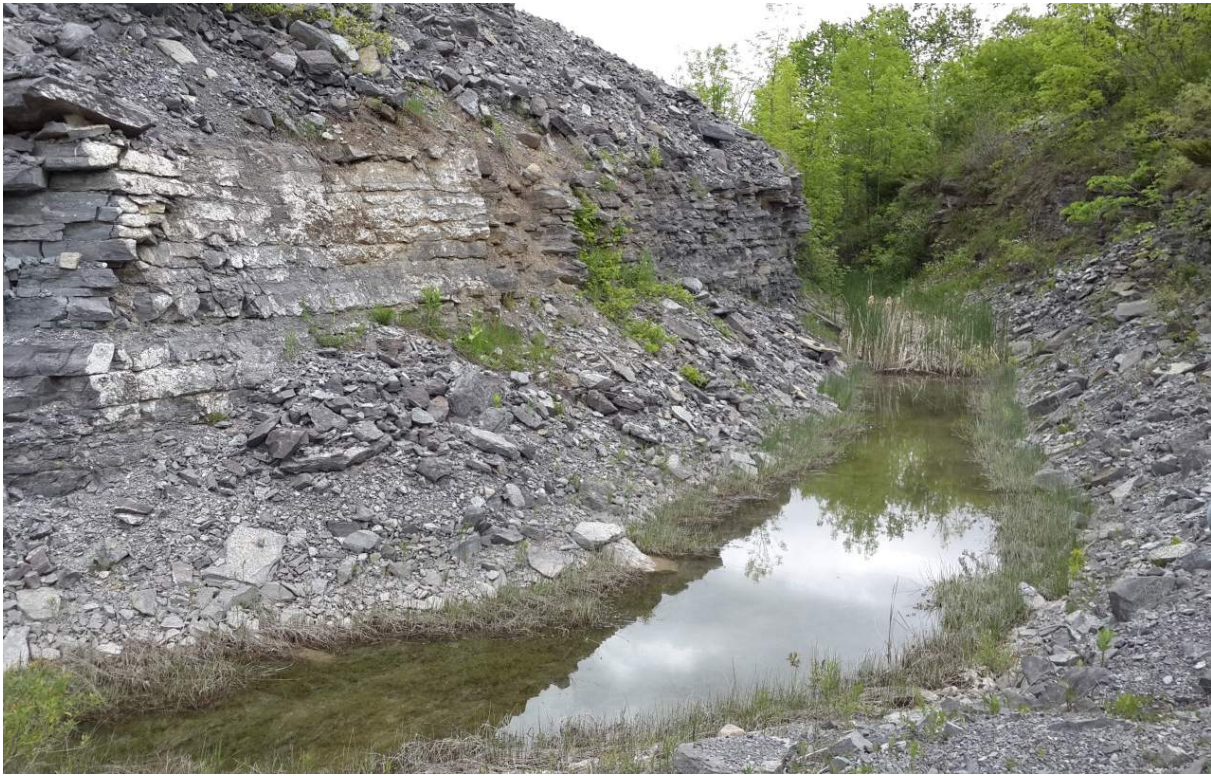
Photo 13: Drainage ditch exiting quarry at the south end (SW3)

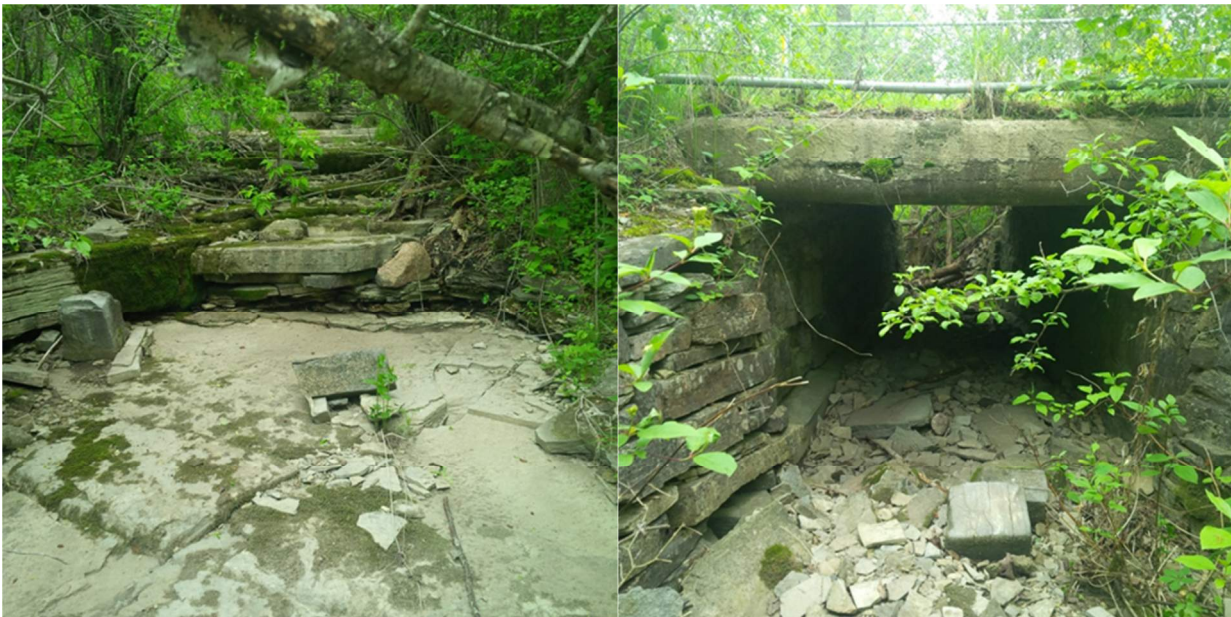
Photo 14: Rectangular culvert under K&P trail (taken from upstream end)

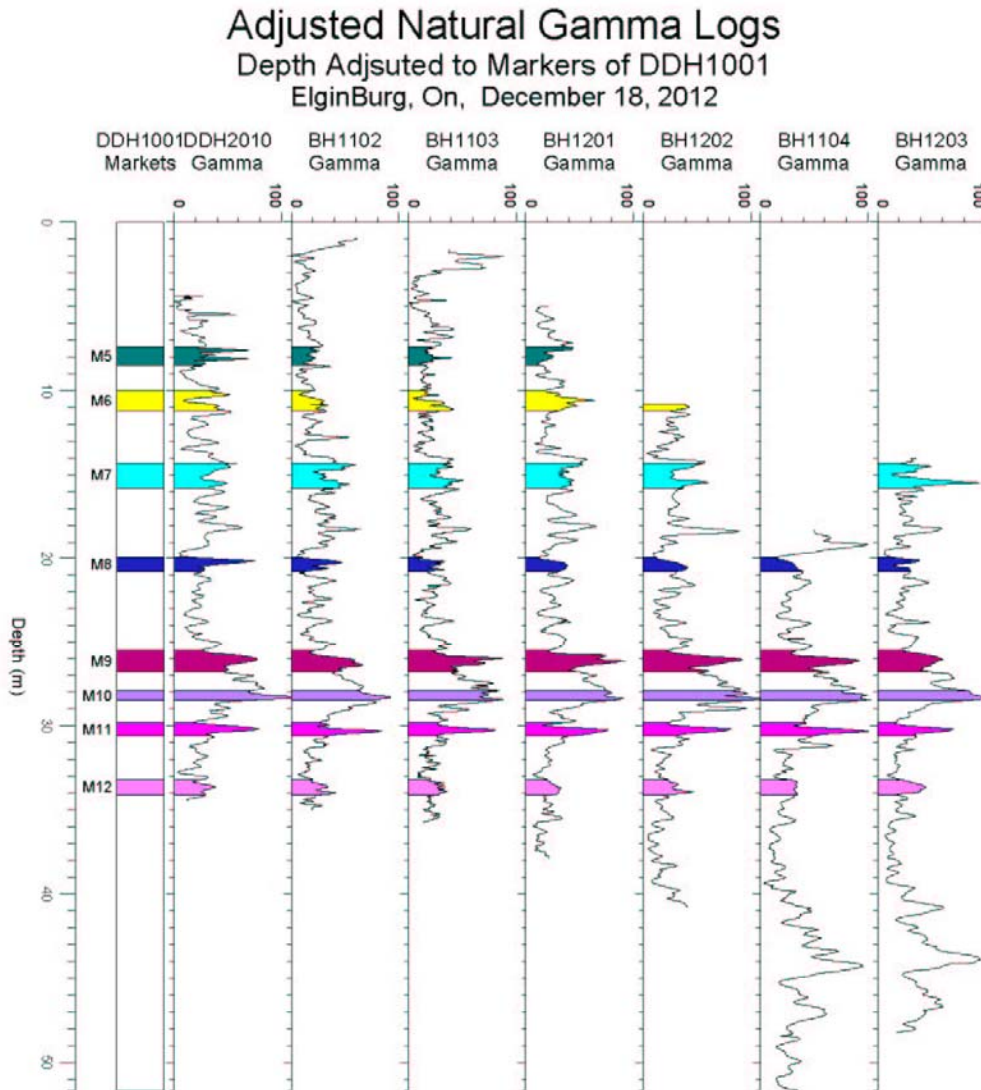
Figure 2 - Natural Gamma Data – Levelled to Markers

The natural gamma data maps profiles for each hole are very similar when adjusted by a vertical shift and aligned to specific features in the profiles.

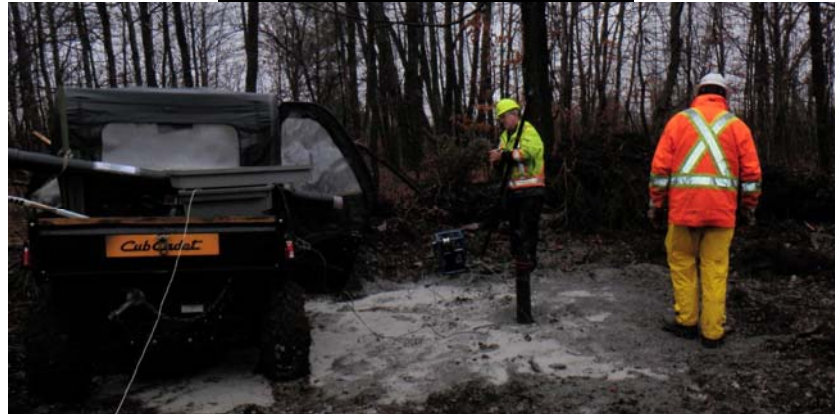
Setting Up System – BH1203

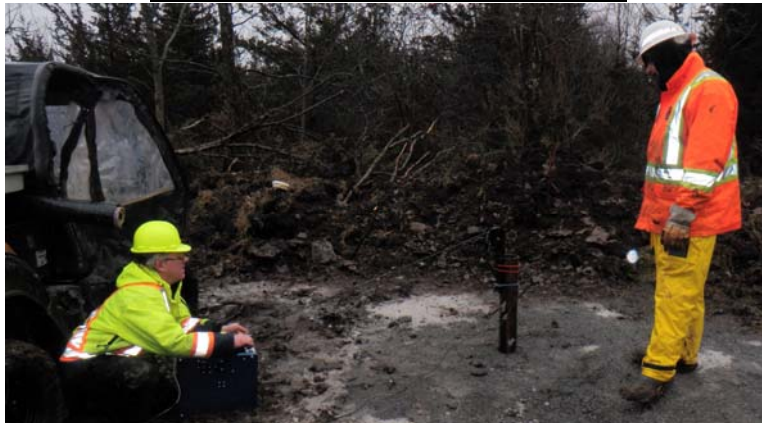
The IFG BMP06 Probe – BH1102

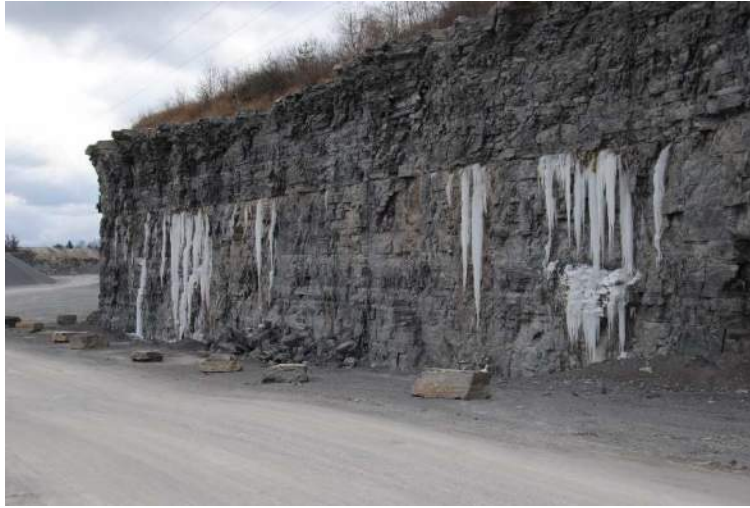
MORRISON HERSHFIELD

Photo 1: Existing Elginburg South Quarry

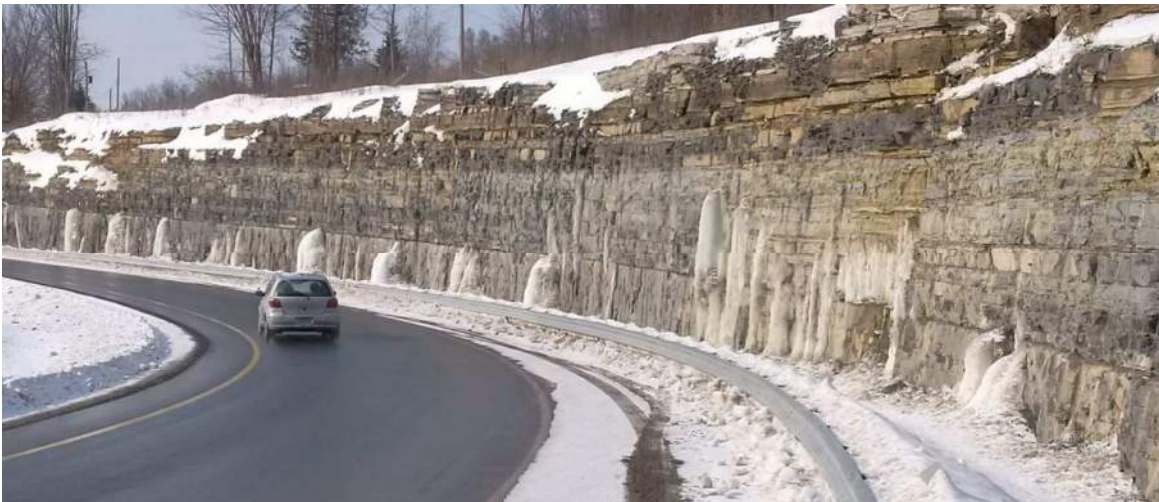
Photo 2: Highway 401 and Highway 11 Intersection – Channelized flow in a planar feature. Note the regularly-spaced ice mounds, about car height.

In this hydrogeological environment, wells in the area of the Elginburg Quarry take their water from discrete water bearing zones that are channels embedded within planar features. Given the otherwise very low permeability of the rock, the most likely scenario for a well impact is that such a channel is drained into the quarry when it is intercepted by the advancing rock face.
